DETERIORATION OF
STRUCTURES OF TIMBER, METAL,
AND CONCRETE EXPOSED TO
THE ACTION OF SEA-WATER

FIFTEENTH REPORT OF THE COMMITTEE OF THE
INSTITUTION OF CIVIL ENGINEERS

*Being a general description of the experimental work carried out by
the Committee to date*

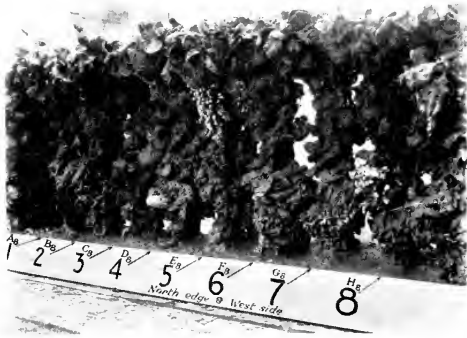
FIG. 22.

SHELL FAUNA ON BARS EXPOSED TO COMPLETE IMMERSION AT AUCKLAND AFTER 10 YEARS.

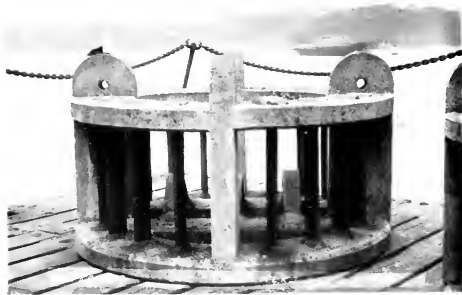
FIG. 23.

FRAME H IN SITU, CONTAINING BARS EXPOSED TO AERIAL CONDITIONS AT PLYMOUTH FOR 10 YEARS.

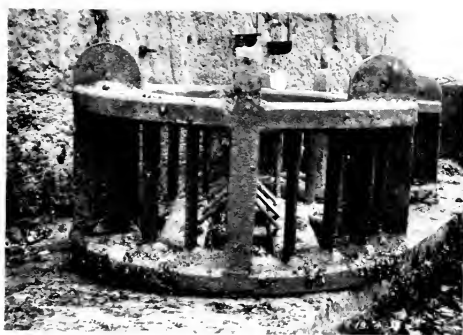
FIG. 24.

FRAME V IN SITU, CONTAINING BARS EXPOSED TO
HALF-TIDE CONDITIONS AT PLYMOUTH FOR
10 YEARS.

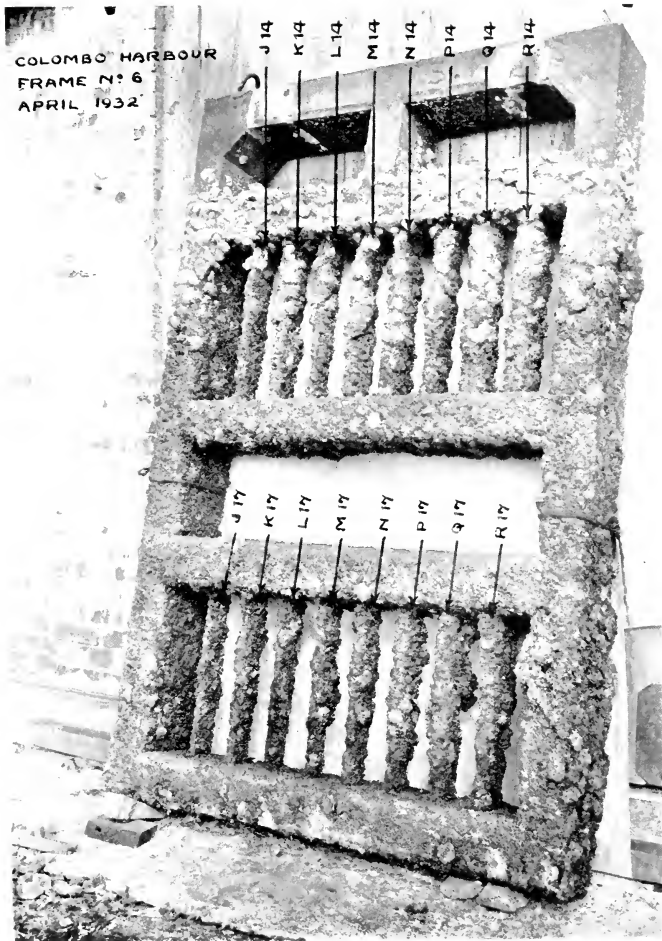
FIG. 26.

FRAME CONTAINING BARS EXPOSED TO HALF-TIDE CONDITIONS (UPPER PART) AND TO COMPLETE IMMERSION IN SEA-WATER (LOWER PART) AT COLOMBO FOR 10 YEARS.

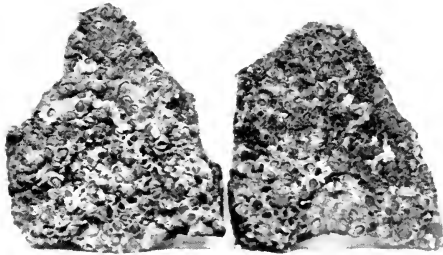
FIG. 29.

SHELLS REMOVED FROM MILD STEEL AND LOW MOOR WROUGHT IRON (C 42 AND N 42) PAIRED AND COMPLETELY IMMersed IN SEA-WATER AT AUCKLAND FOR 5 YEARS.

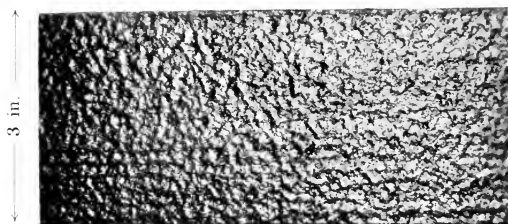
FIG. 30.

LOW MOOR WROUGHT IRON (N 20) EXPOSED TO AERIAL CORROSION AT HALIFAX FOR 10 YEARS, SHOWING POCKS AND FURROWS.

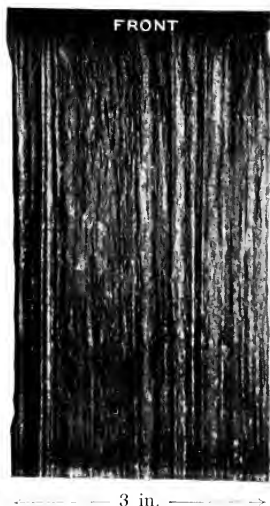
LOW MOOR WROUGHT IRON (N 69) EXPOSED TO COMPLETE IMMERSION IN SEA-WATER AT HALIFAX FOR 5 YEARS, SHOWING FIBROUS STRUCTURE.

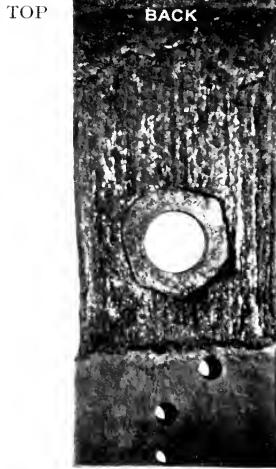
FIG. 36.

SWEDISH CHARCOAL IRON (P 55),
BOLTED TO MILD STEEL AND EXPOSED
TO HALF-TIDE CONDITIONS AT
HALIFAX FOR 5 YEARS, SHOWING
SEVERE CORROSION AND FIBROUS
STRUCTURE AT LOWER END.

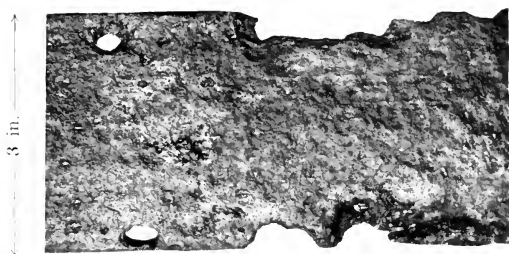
FIG. 40.

INGOT IRON (M 11) EXPOSED TO AERIAL CORROSION AT COLOMBO FOR 10 YEARS.

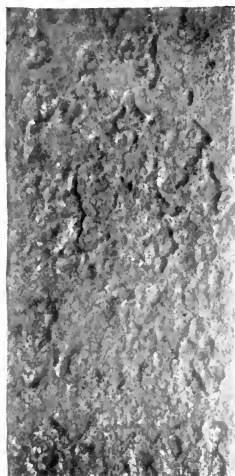
FIG. 42.

INGOT IRON (M 23) EXPOSED TO HALF-TIDE CONDITIONS AT HALIFAX FOR 10 YEARS, BOTTOM LEFT-HAND EDGE.

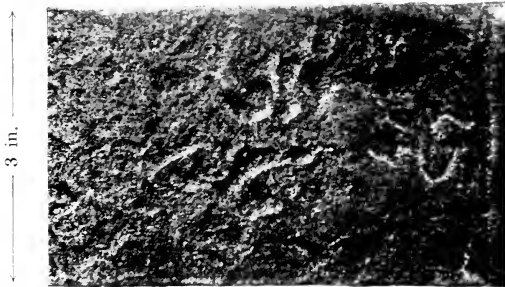
FIG. 43.

INGOT IRON (M 38) EXPOSED TO COMPLETE IMMERSION IN FRESH WATER AT PLYMOUTH FOR 10 YEARS, SHOWING VERMIFORM CORROSION.

| | PAGE |
|---|---|
| "Vermiform" corrosion described; only occurred with cleaned bars | 71 |

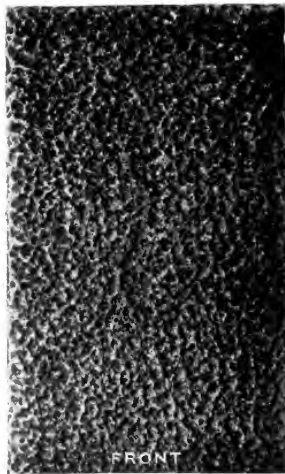
FIG. 44.

MILD STEEL (B 19) EXPOSED TO AERIAL CORROSION AT HALIFAX FOR 5 YEARS, SHOWING POCK-MARKING.

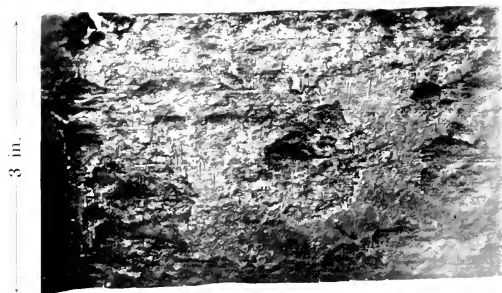
FIG. 47.

MILD STEEL (B 8), HIGH IN SULPHUR AND PHOSPHORUS, EXPOSED TO COMPLETE IMMERSION IN SEA-WATER AT AUCKLAND FOR 10 YEARS, SHOWING DEEP PITTING.

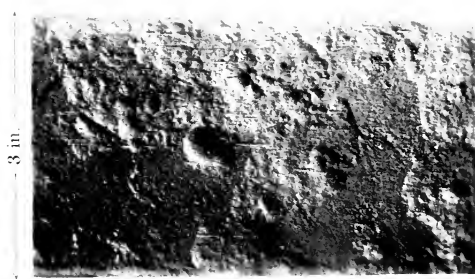
FIG. 51.

MILD STEEL (F 8) EXPOSED TO COMPLETE IMMERSION IN SEA-WATER AT AUCKLAND FOR 10 YEARS, SHOWING PITTING.

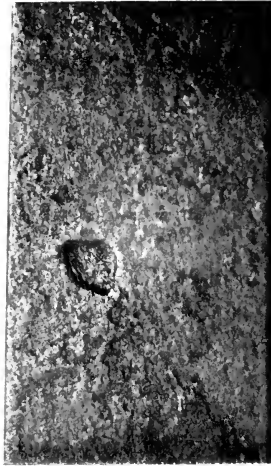
FIG. 56.

CLEANED MILD STEEL (C 26) EXPOSED TO COMPLETE IMMERSION IN SEA-WATER AT HALIFAX FOR 10 YEARS, SHOWING CHANNEL NEAR LOWER EDGE.

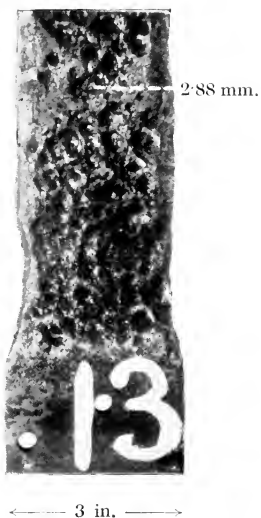
FIG. 59.

MEDIUM CARBON STEEL (E 13)
EXPOSED TO HALF-TIDE CONDITIONS
AT COLOMBO FOR 5 YEARS.

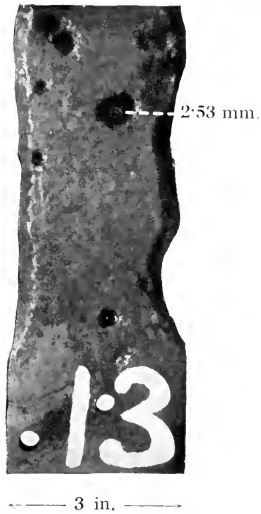
FIG. 72.

0.635 PER CENT. COPPER STEEL (G 13)
EXPOSED TO HALF-TIDE CONDITIONS
AT COLOMBO FOR 5 YEARS.

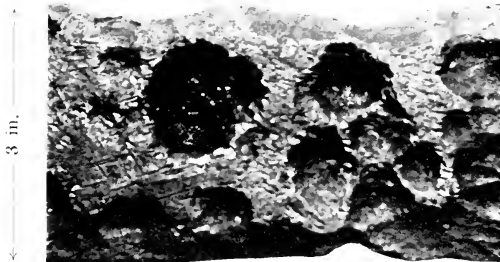
FIG. 73.

0.635 PER CENT. COPPER STEEL (G 14) EXPOSED TO HALF-TIDE CONDITIONS
AT COLOMBO FOR 10 YEARS, SHOWING FACE.

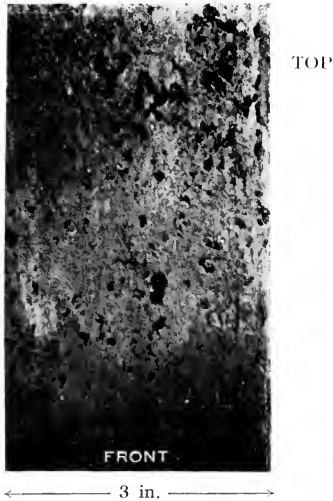
FIG. 85.

13·5 PER CENT. CHROMIUM STEEL (J 25) AFTER COMPLETE IMMERSION IN SEA-WATER AT HALIFAX FOR 5 YEARS, SHOWING PIN-HOLE PITTING.

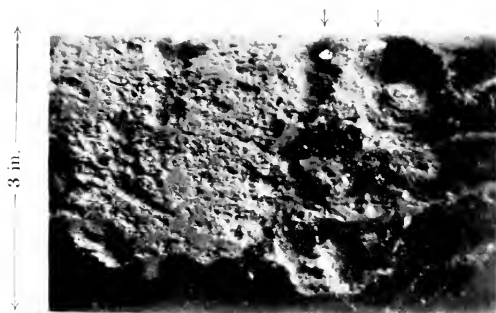
FIG. 87.

13.5 PER CENT. CHROMIUM STEEL (J 26) EXPOSED TO COMPLETE IMMERSION IN SEA-WATER AT HALIFAX FOR 10 YEARS, PERFORATED BY CORROSION.

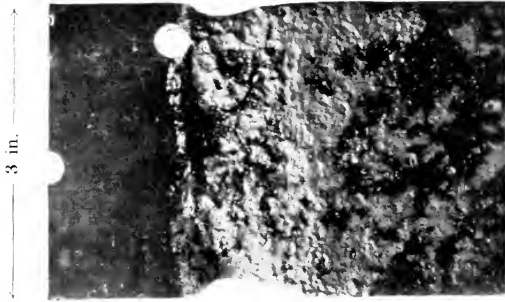
FIG. 95.

3.75 PER CENT. NICKEL STEEL (K 23) EXPOSED TO HALF-TIDE CONDITIONS AT HALIFAX FOR 10 YEARS, SHOWING DEEP CORROSION AT CONCRETE LEVEL.

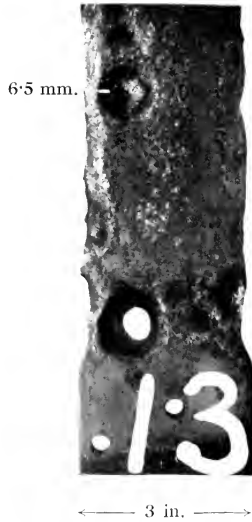
FIG. 97.

3.75 PER CENT. NICKEL STEEL (K 13)
EXPOSED TO HALF-TIDE CONDITIONS
AT COLOMBO FOR 5 YEARS, SHOWING
HOLE 3 MM. IN DIAMETER NEAR
LOWER END, AND VERY DEEP PIT
VERTICALLY ABOVE IT.

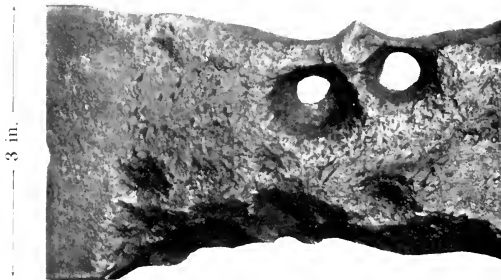
FIG. 98.

3.75 PER CENT. NICKEL STEEL (K 14) EXPOSED TO HALF-TIDE CONDITIONS AT
COLOMBO FOR 10 YEARS.

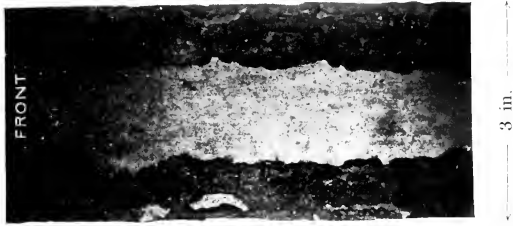
FIG. 102.

BARS OF 3.75 PER CENT. NICKEL STEEL (K) EXPOSED AT COLOMBO FOR 10 YEARS.

Corrosion may follow the direction of the rolling of the bar during manufacture, leading to well-defined *channelling* as shown in Figs. 102 and 106.

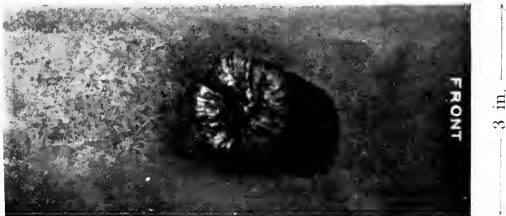
FIG. 103.

36 PER CENT. NICKEL STEEL (L 25) EXPOSED TO COMPLETE IMMERSION IN SEA-WATER AT HALIFAX FOR 5 YEARS.

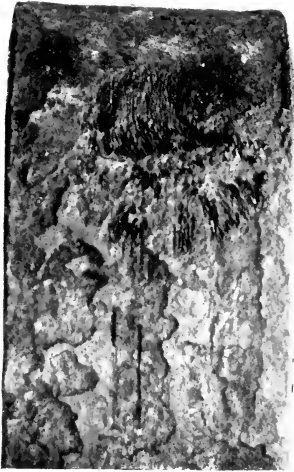
FIG. 105.

36 PER CENT. NICKEL STEEL (L 70)
BENT AT RIGHT ANGLES AND EX-
POSED TO COMPLETE IMMERSION IN
SEA-WATER AT PLYMOUTH FOR 5
YEARS, SHOWING FIBROUS STRUCTURE
AT OUTSIDE OF BEND.

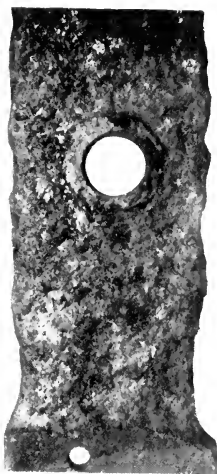
FIG. 110.

HOT-BLAST CAST IRON (Q 56) EXPOSED (IN CONTACT WITH MILD STEEL) TO HALF-TIDE CONDITIONS AT COLOMBO FOR 5 YEARS.

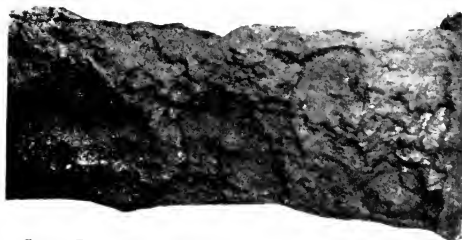
FIG. 111.

COLD-BLAST CAST IRON (R 44)
CARRYING FOUR MILD STEEL BOLTS
AND EXPOSED TO HALF-TIDE
CONDITIONS AT COLOMBO FOR 5
YEARS.

Nature of the Corrosion at Half-Tide Level.—There was no pocking such as characterized many of the aerial bars, and corrosion was in general more uneven and pitting more serious. The corrosion was particularly severe at the lower ends of the bars (Figs. 32, 77 and 111) which remained wet much longer than the upper, both because of the drainage of the water from above and because of their position nearer to low-water level. The levels where the bars entered the concrete were usually well defined (Figs. 32 and 57), although occasionally corrosion had penetrated for various distances under the concrete (Figs. 77, 82 and 95), sometimes resulting in an enlargement of an identification-hole and making it look like a perforating pit (Fig. 50). Occasionally the bars were very appreciably thinned near their bottom ends (Figs. 32, 37 and 41). Pitting varied enormously in character, from numerous shallow to large circular pits (Figs. 57, 59, 78 and 96), which were often very deep. Thus the large circular pit of bar G14 (Fig. 73) had penetrated three-quarters of the way through the bar. The pit shown in Fig. 74 occurred on the opposite side of the same bar and penetrated almost half way through the bar. Sometimes the pits were mere pinholes, thus representing incipient pitting. Some bars showed oval or elongated pitting (Fig. 58). With the wrought irons, N and P, corrosion proceeded in narrow furrows down the length of the bar following the direction of rolling (Fig. 36).

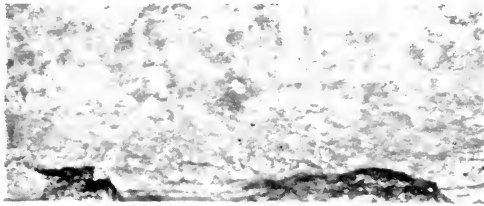
FIG. 114.

COLD-BLAST CAST IRON (R 8) EXPOSED TO COMPLETE IMMERSION IN SEA-
WATER AT AUCKLAND FOR 10 YEARS, SHOWING ATTACKED EDGE.

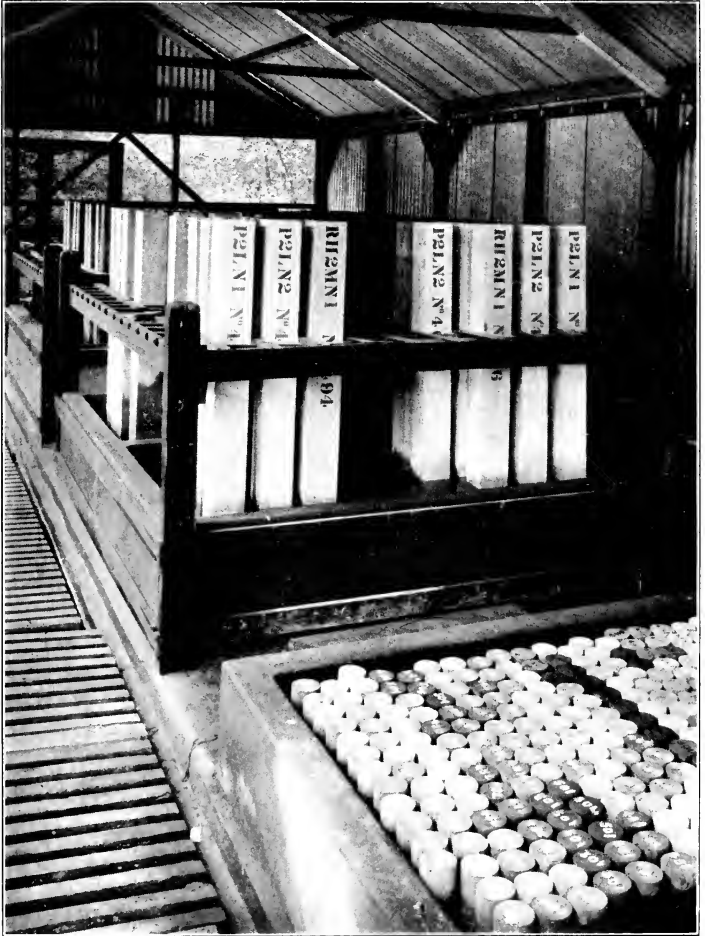
FIG. 120.

EXPOSURE TANK AT SMELTERESS.

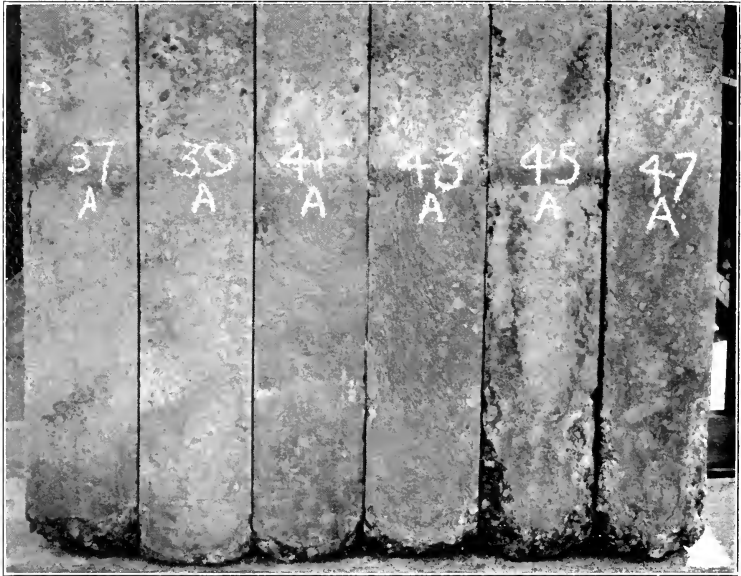
FIG. 128.

1 part cement.
3 parts sand.
6 „ gravel.

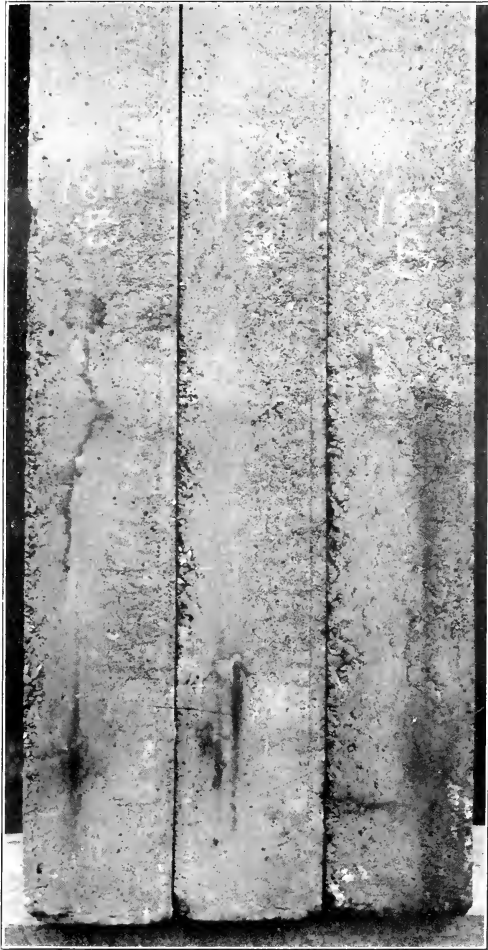
FIG. 129.

LEAN MIXTURE OF HIGH ALUMINA CEMENT (1 : 3 : 6), NORMAL CONSISTENCY,
AFTER 4 YEARS IN ARTIFICIAL SEA-WATER OF THREE TIMES NORMAL
CONCENTRATION, AT WATFORD.

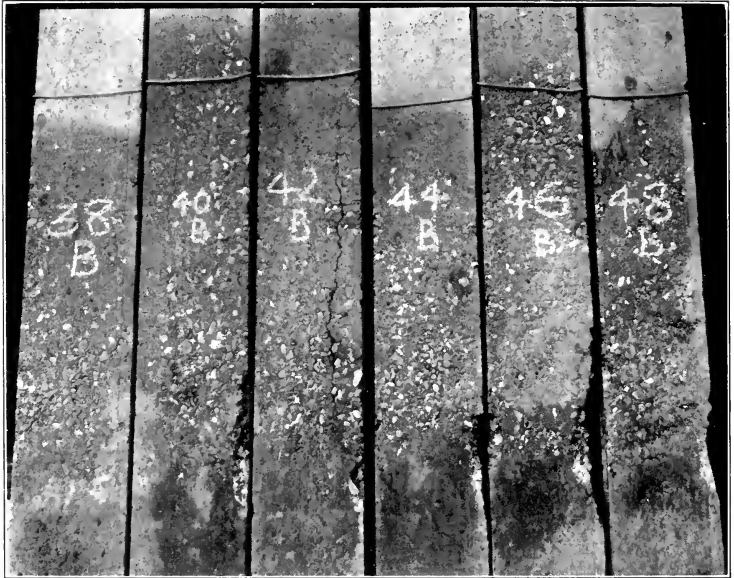
FIG. 130.

LEAN MIXTURE OF NORMAL PORTLAND CEMENT (1 : 3 : 6), NORMAL CONSISTENCY, AFTER $3\frac{1}{2}$ YEARS IN ARTIFICIAL SEA-WATER OF THREE TIMES NORMAL CONCENTRATION, AT WATFORD.
